-- LAUREL LAKE DAM --
PHASE I
INSPECTION / EVALUATION REPORT

Dam Name: Laurel Lake Dam

NID ID#: MA00263

Date of Inspection: September 19, 2022

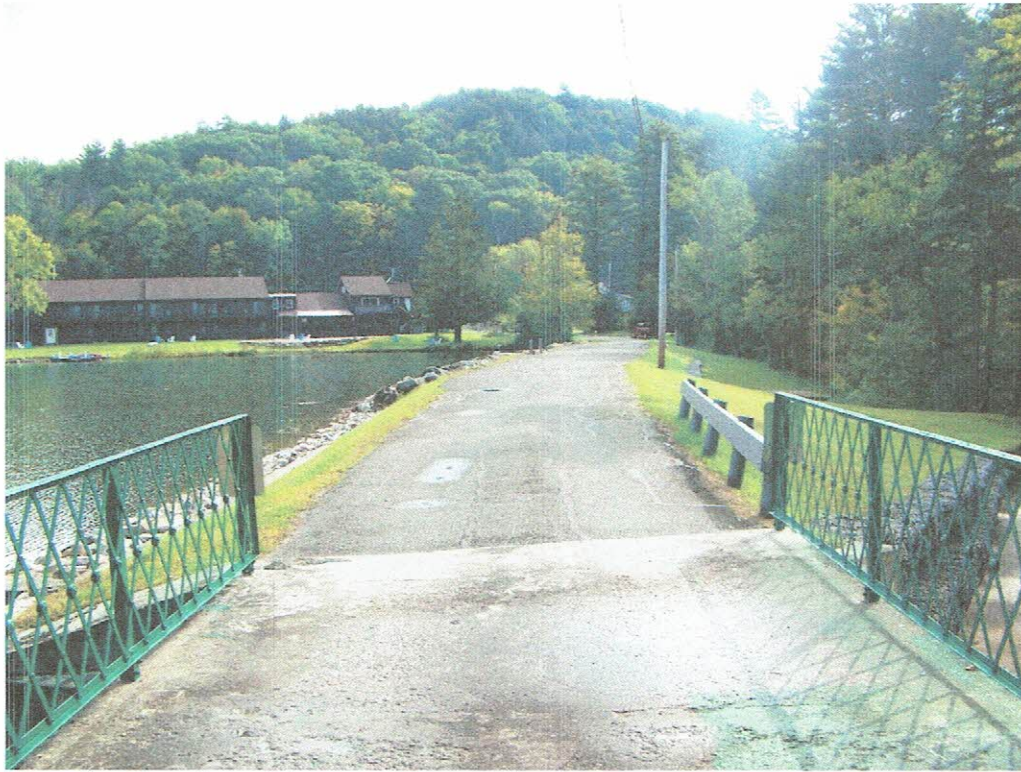
- **Crest** – The dam crest has generally good horizontal and vertical alignment. Repairs to the bituminous concrete surface are visible. Crack sealing was completed in 2022. Some cracking of the roadway surface remains, but, is not significant to the stability of the dam structure at this time. See photos 5, and 6 – Appendix A.

Photo 5 – *Overview of dam crest from right abutment*

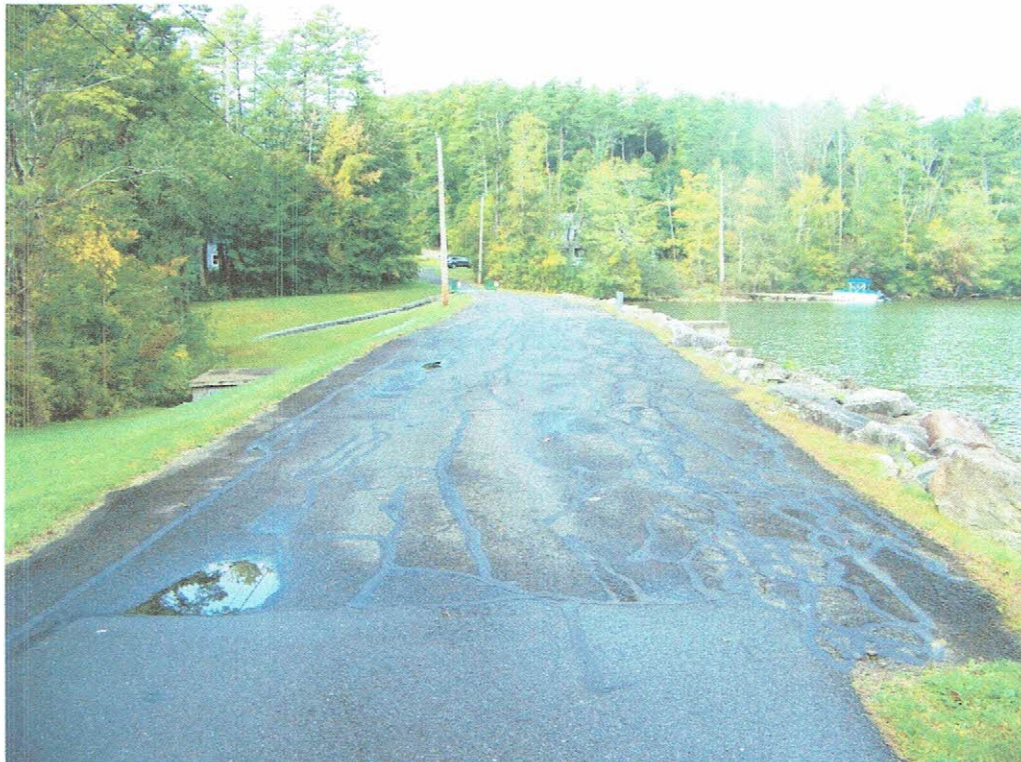
Photo 6 – *Overview of dam crest from left abutment*

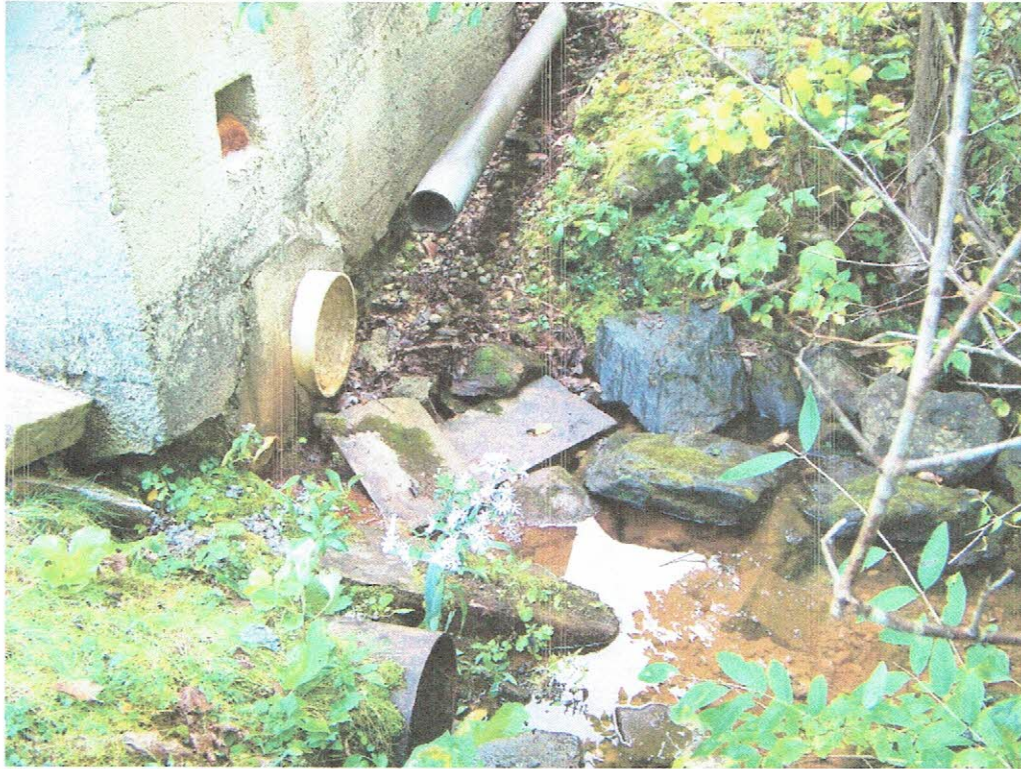
Photo 19 – *Gatehouse outlet drains*

- Gate house corner near the drains needs concrete repair.

1. Concrete repairs at corner of gatehouse near drains.	<u>\$2,000</u>
Total	\$2,000
