-- LAUREL LAKE DAM --
PHASE I
INSPECTION / EVALUATION REPORT

Dam Name: Laurel Lake Dam

NID ID#: MA00263

Date of Inspection: September 19, 2022

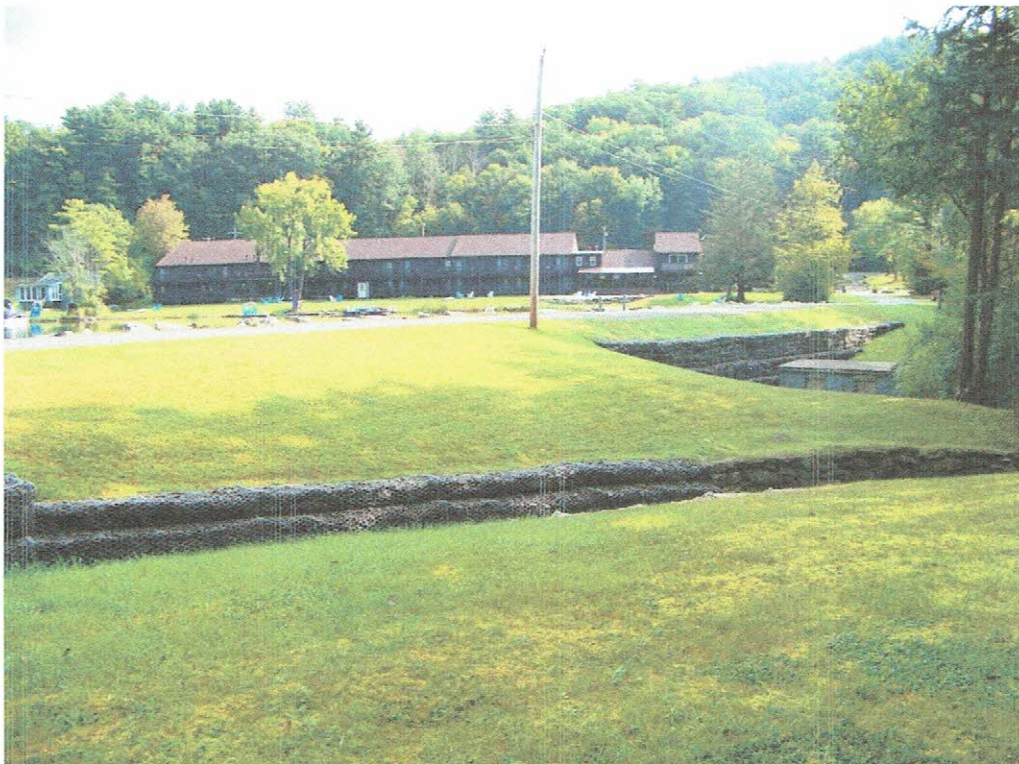
Photo 2 – *Overview of dam from downstream*

- **Downstream Face** – The face is generally vegetated with grass that is well maintained. There is a gabion basket wall system along the central portion of the slope directly uphill of the gate house. See photos 2, 5, 6, 7, 8, 10, 15 and 16 – Appendix A.

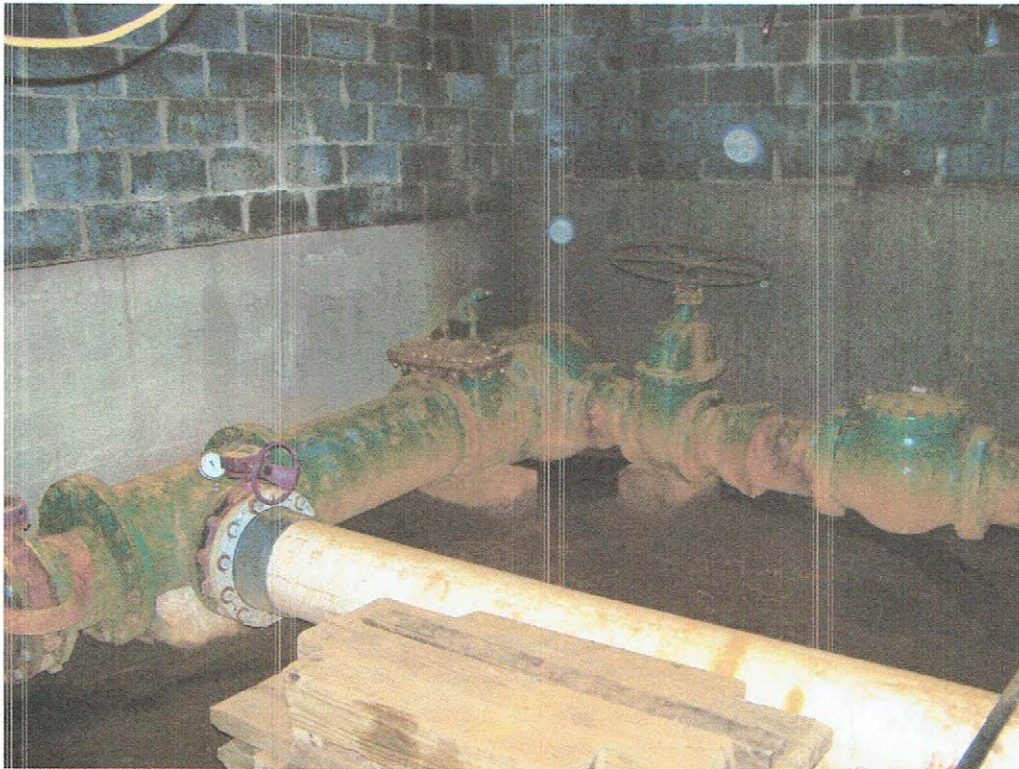
Photo 17 – *Overview of gatehouse interior*

- **Drains** – The dam intake structure on the upstream side of the crest consists of a trash rack with a 16 inch gravity fed pipe that passes through the dam embankment. The pipe is controlled by a gate valve at the intake structure and inside the gate house. One of the discharge lines is routed to the former Eagle Mill of the Schweitzer-Mauduit complex about a mile downstream where the water had been used for process water. There is a bypass pipe with two parallel 12" valves on the main which allows for water to be discharged to the main spillway channel. See photos 17, 18 and 19 – Appendix A. Minor concrete repairs should be completed.

1. Concrete repairs at corner of gatehouse near drains.	<u>\$2,000</u>
Total	\$2,000
